Debris/Ice/TPS Assessment And Photographic Analysis For Shuttle Mission STS-33R

Charles G. Stevenson
NASA/Kennedy Space Center

DEBRIS/ICE/TPS ASSESSMENT
AND
PHOTOGRAPHIC ANALYSIS
OF
SHUTTLE MISSION STS-33R

November 22, 1989

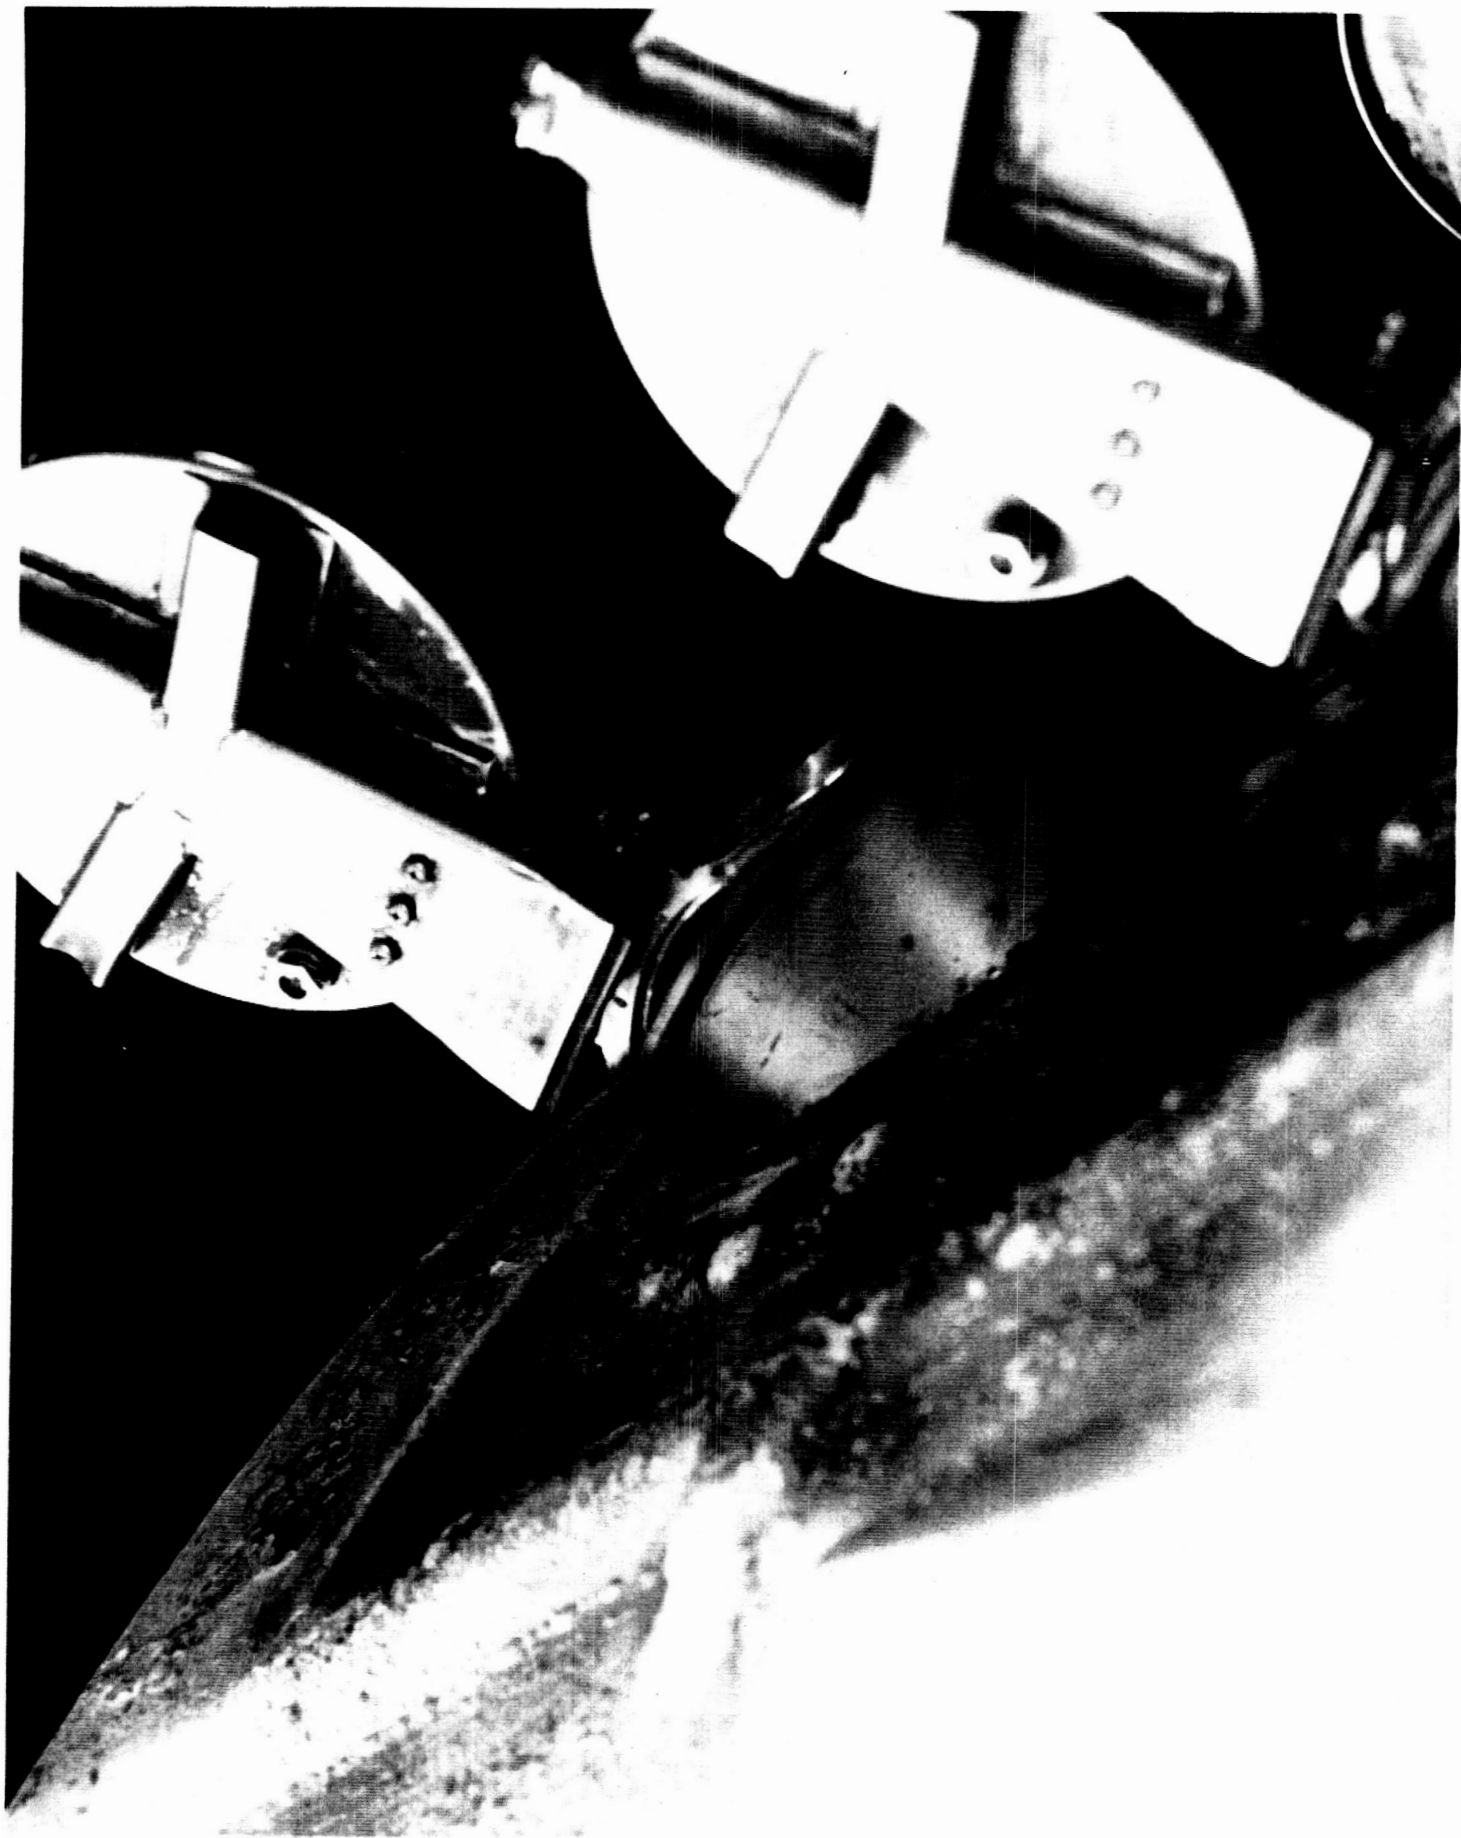
Close-in view of bent attach rings on forward BSM aero
heat shield covers

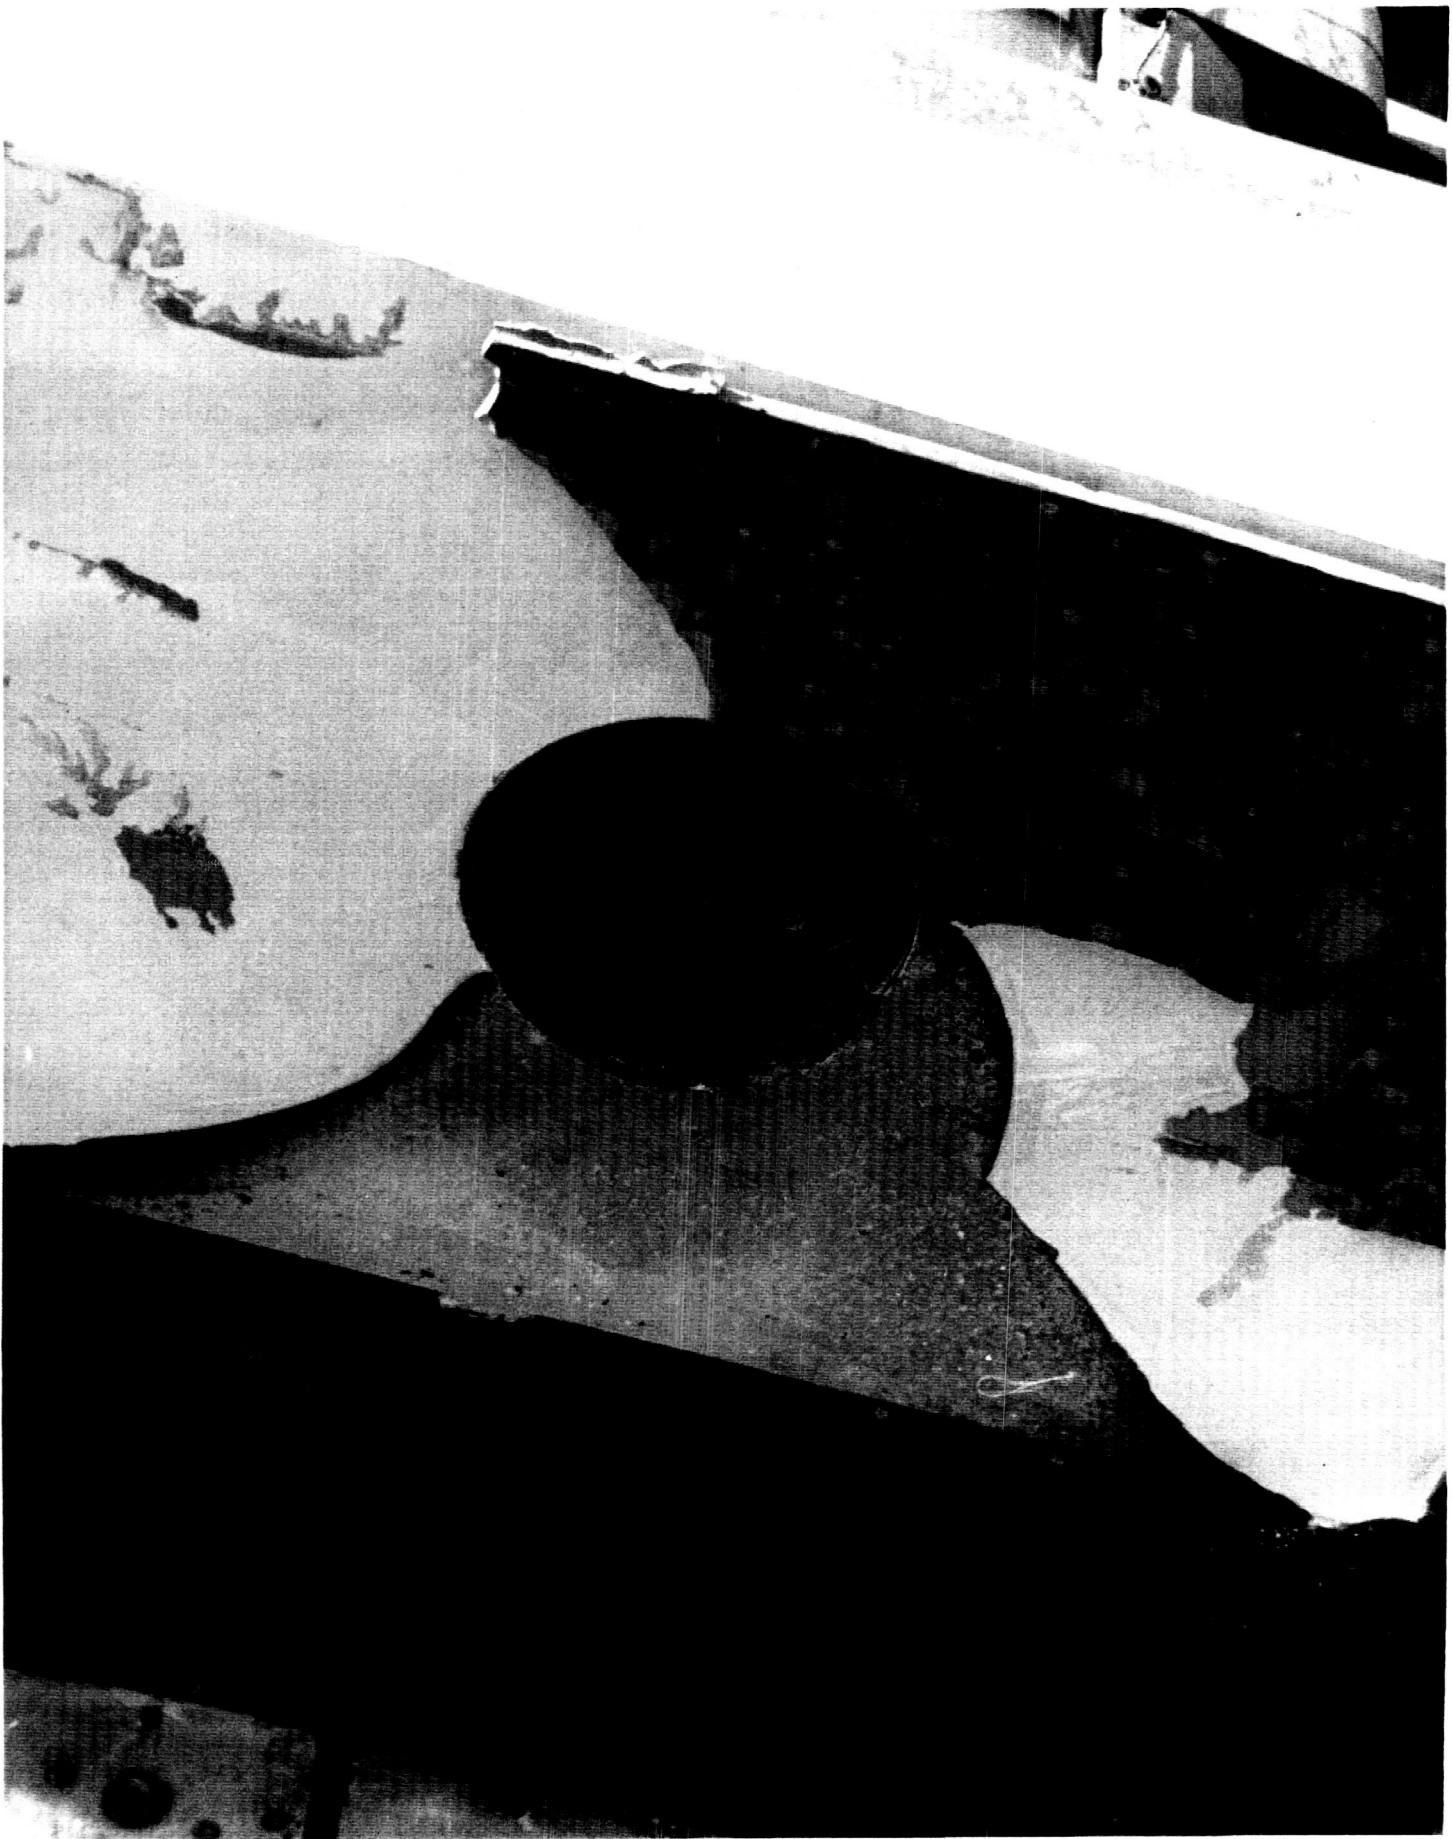
Broaching of the RH aft skirt HDP #3 stud hole and loss of
40% of the bonded shim during ascent due to stud hang-up
